Baseline Survey for a Bank Stability Assessment for the Mpopana River

Version -Final Report

24 August 2015

GCS Project Number: 14-452

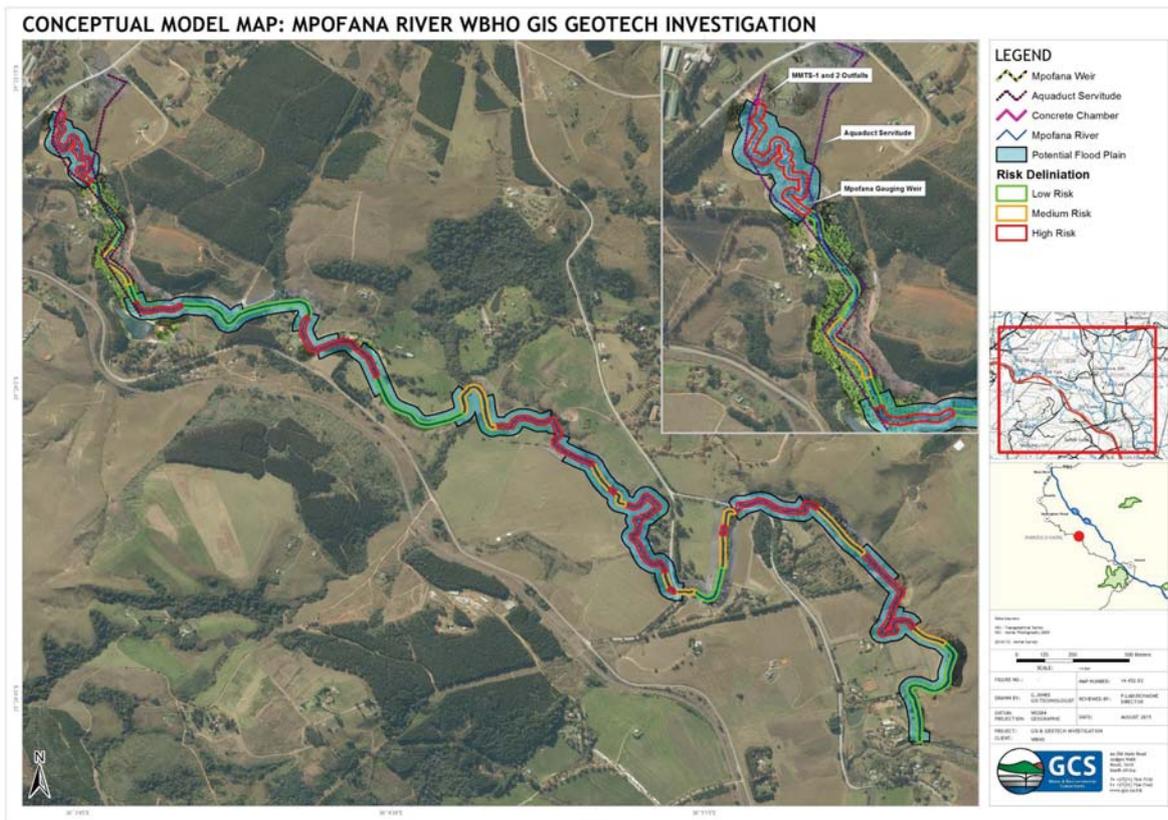
Figure 2 Visual Conceptual Model

Based on the field assessments mentioned in Section 5, the following can be said concerning the susceptibility of the river's banks to erosion, when the flow rate and water volume in the river is increased:

- Portions of the river which are deemed to be possible floodplains consisting of fine sandy Clay alluvium overlying either boulder horizons or bedrock with variable consistency, have a moderate to high propensity for erosion.

- Portions of the river which are deemed to have residual soil overlying bedrock (generally sections of the river where shale bedrock is observed), consisting of either a silty gravelly Sand or sandy Clay colluvium or hillwash, overlying a closely to medium jointed very soft to soft rock Shale, have a low to moderate propensity for erosion. However reassessment should be undertaken once the water level has been raised to assess the response of the rock mass.

- River bank gradients exceeding 1.5V:1H are deemed to be of concern and will have possible increased erosive potential. However, should the bank consist of bedrock this erosive potential decreases in contrast to those banks composed of alluvium within possible floodplains;

- Areas of high, medium and low risk are depicted in red, orange and green respectively. The areas outlined with blue show the banks along the river (side of the river dependant) which are considered potential floodplains and carry potential risk of erosion. Those areas not highlighted in blue are deemed carry low to no risk of erosion.
